Pentium® II Xeon™ Processor Specification Update

Release Date: August 1998

Order Number: 243776-004

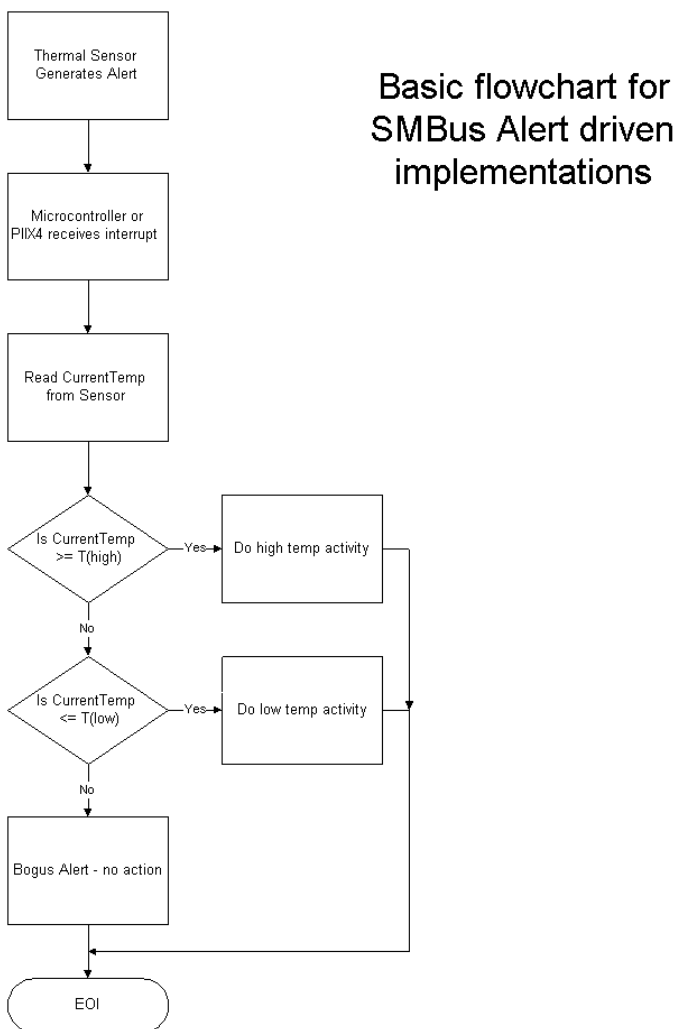
Figure 2. Workaround Flowchart: SMBALERT#-Driven System

Under the conditions described below, the thermal sensor incorrectly generates the SMBALERT# interrupt. *All* of the following conditions must be met to trigger a false interrupt:

WORKAROUND: Three different (mutually exclusive) workarounds are possible:

1. Before servicing an interrupt from the thermal sensor, read and compare the processor thermal reading with the threshold limits (T_{HIGH} or T_{LOW}). Figures 2 and 3 provide basic flowcharts for the implementation of this workaround in an interrupt driven system.
2. If the firmware implemented polls the Status Register only, then before taking any action, re-read the temperature register and do a comparison with the alarm threshold limits (T_{HIGH} or T_{LOW}) to determine if the value is actually still within the temperature window.
3. Use a temperature polling scheme to monitor the processor temperature.
